Rapid Recovery

By Joe Erwin, P.E., and Brian Fuller, P.E.

After a major landslide closed a section of the iconic State Route 1 through central California's scenic coastal region of Big Sur, the California Department of Transportation swung into action. Relying on teamwork, innovative processes, and cutting-edge technology, Caltrans developed balanced solutions to restore access to this vital arterial as rapidly as possible while taking steps to protect the highway and its travelers from the effects of similar events in the future.

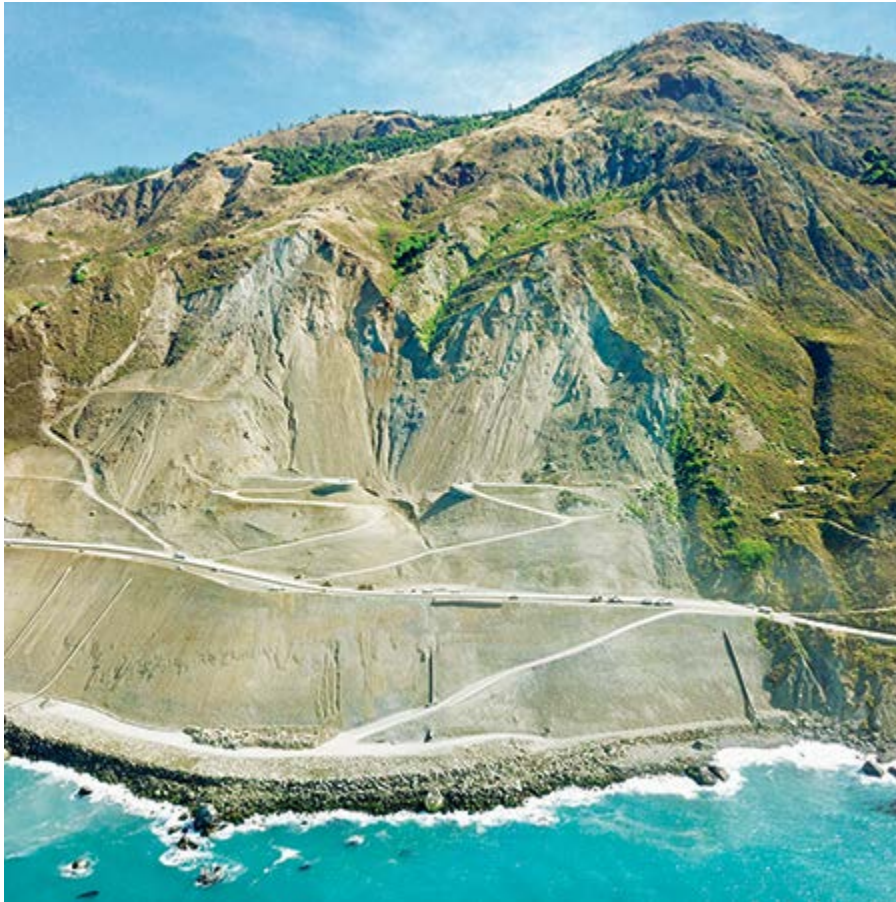
To reopen State Route 1 as quickly and as safely as possible, Caltrans opted to construct a newly relocated highway across the body of the landslide. COURTESY OF JOHN MADONNA CONSTRUCTION

Often, unstable slopes require a combination of mitigating strategies. The extremely large area of the Mud Creek landslide and the rugged, steep terrain of the Big Sur coast highway obviated the use of traditional avoidance and stabilization as feasible engineering alternatives. Improvements considered and analyzed included realignment with a bypass or tunnel, removal of the remaining slide mass, and construction of retaining walls, viaducts, and bridges. All were deemed unsuitable to the site conditions for various reasons, including the absence of bedrock to tie into or the time it would take to plan and complete construction. During an emergency project to reopen a closed highway, the preferred solution often strikes a balance between cost, constructability, and schedule. Ultimately, the strategy devised by Caltrans for addressing the Mud Creek landslide involved a combination of protection and management, in this case by constructing a newly relocated highway across the body of the landslide.

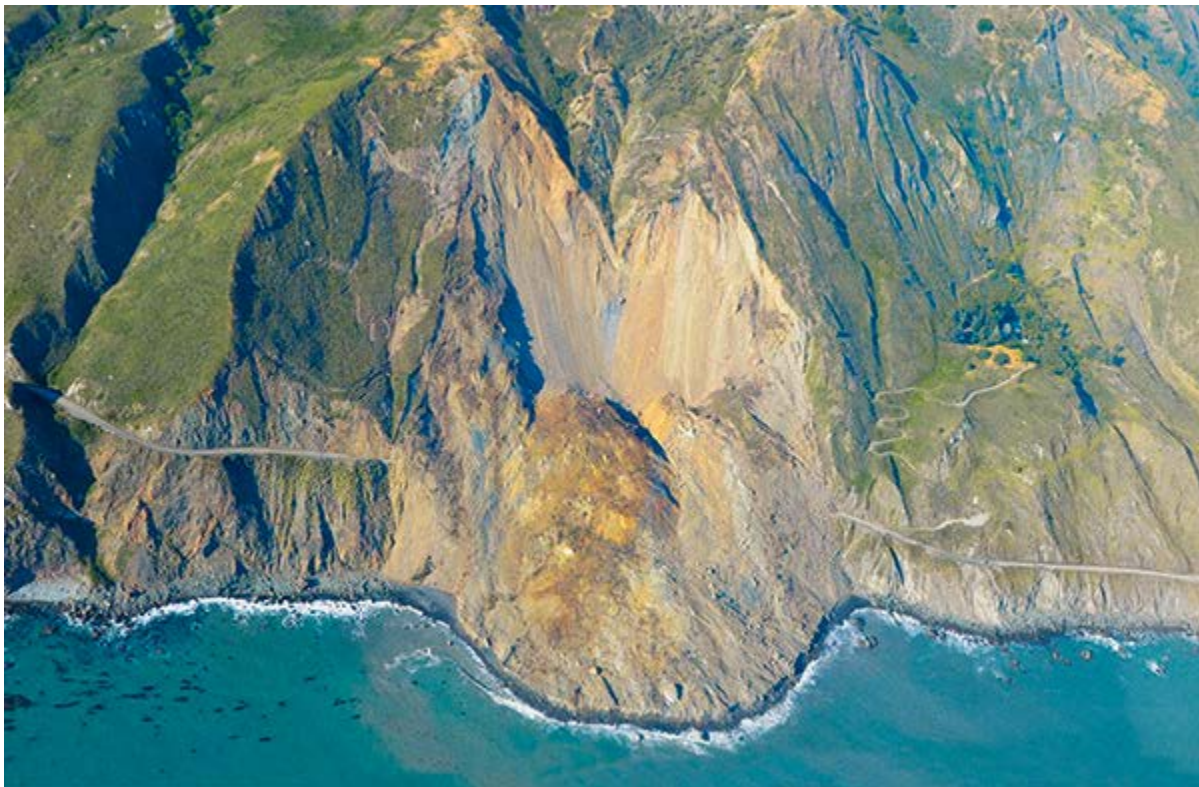
In May 2017, a massive landslide buried about 1,000 ft of State Route 1 beneath 160 ft of earthen materials. COURTESY OF JOHN MADONNA CONSTRUCTION

At one point in May 2017, a subcontractor foreman determined it was unsafe to continue working on the highway and demobilized all the construction equipment from the site. The final pieces of equipment were removed on May 19. The next evening, 50 acres of land and more than 5 million cu yd of earth broke free from the mountainside. With a thunderous roar—likened to an earthquake by a nearby resident—a new 15-acre peninsula was created. About 1,000 ft of State Route 1 was now buried beneath 160 ft of earthen material. The new 2,400 ft long coastline jutted out 550 ft into the Pacific Ocean (see "Major Landslides on Iconic Coastal Roadway Occupy Caltrans in Big Sur Region," *Civil Engineering*, July/August 2017, pages 16-17). Thanks to the expert judgment of the foreman, miraculously no one was injured or killed in the catastrophic landslide.

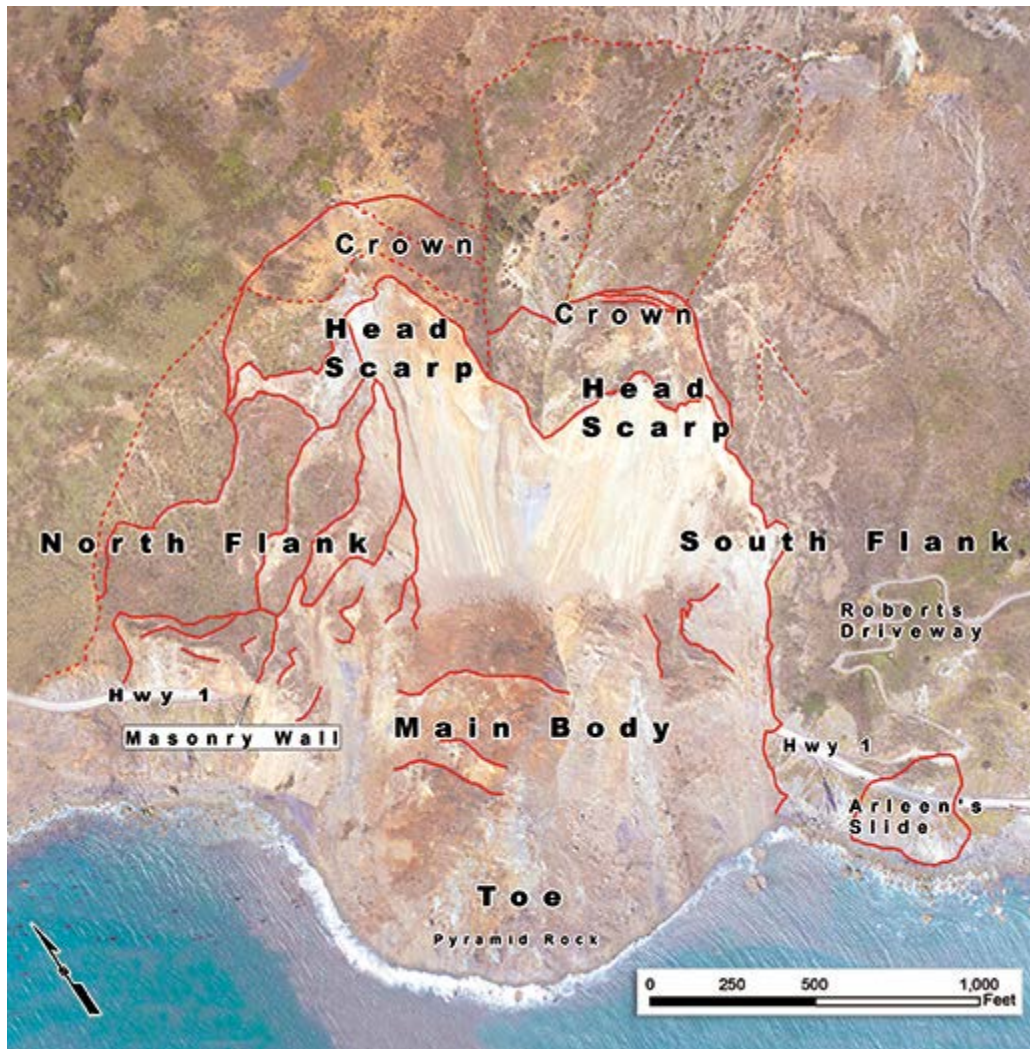
Although the Mud Creek slide was much larger than typical, it still behaved in a way that has been witnessed before. The perimeter slide areas, near the scarp and flanks, settled over time into a more natural equilibrium, while the main body remained relatively static. YEH AND ASSOCIATES

Landslides, no matter how large or small, generally consist of the same features. The main body of the slide is the material that moved downslope. The scarp is the freshly exposed mountainside. Between these two features is the head of the slide. The crown of a slide is the material above the scarp, and the flanks are the soil on either side of the main body and scarp. The toe of a slide represents the outer limits of the main body, and in the case of a landslide into the ocean, it is the new shoreline. Although the Mud Creek slide was much larger than typical, it still behaved in a way that has been witnessed before. The perimeter slide areas, near the scarp and flanks, settled over time into a more natural equilibrium, while the main body remained relatively static.

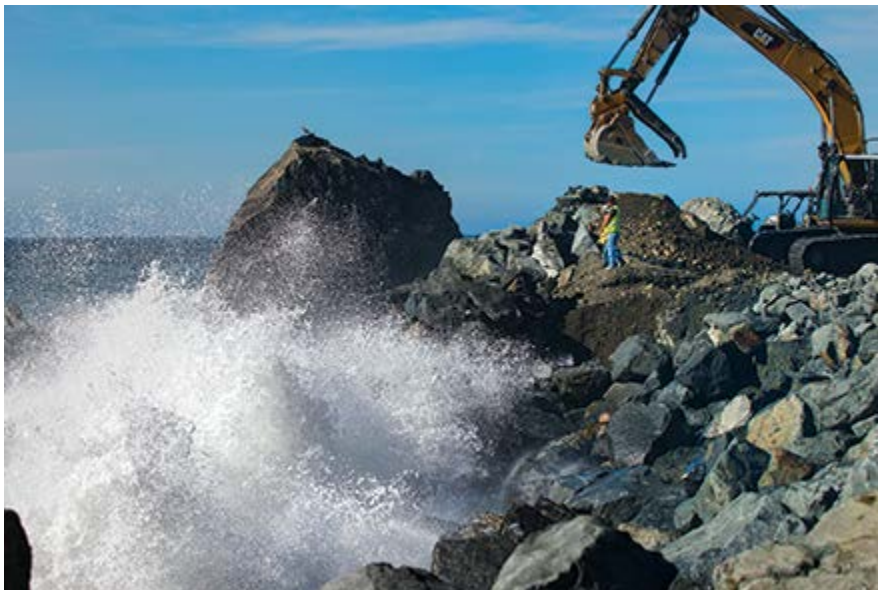
From fall 2017 to winter 2018, several large storms in the northern Pacific Ocean caused large swells and breaking waves at the project site, hampering construction of the rock revetment at the toe of the slide. KYLE EVANS 2018

From fall 2017 through the winter, several large storms in the northern Pacific Ocean caused large swells and breaking waves at the project site, hampering construction of the rock revetment at the toe of the slide. During high tide and on days with larger swells, excavators and equipment were struck by the remains of breaking ocean waves, and in some instances work had to stop until the waves reduced in height and the tide lowered. One of the larger swell events occurred in October 2017, when some of the completed sections of the revetment were overtopped by the waves. Before this incident, the initial revetment design was proposed to be 26 ft tall. However, the swell and resulting waves prompted a design modification in structural height to 40 ft in the sections of revetment most exposed to the energy of the Pacific Ocean.

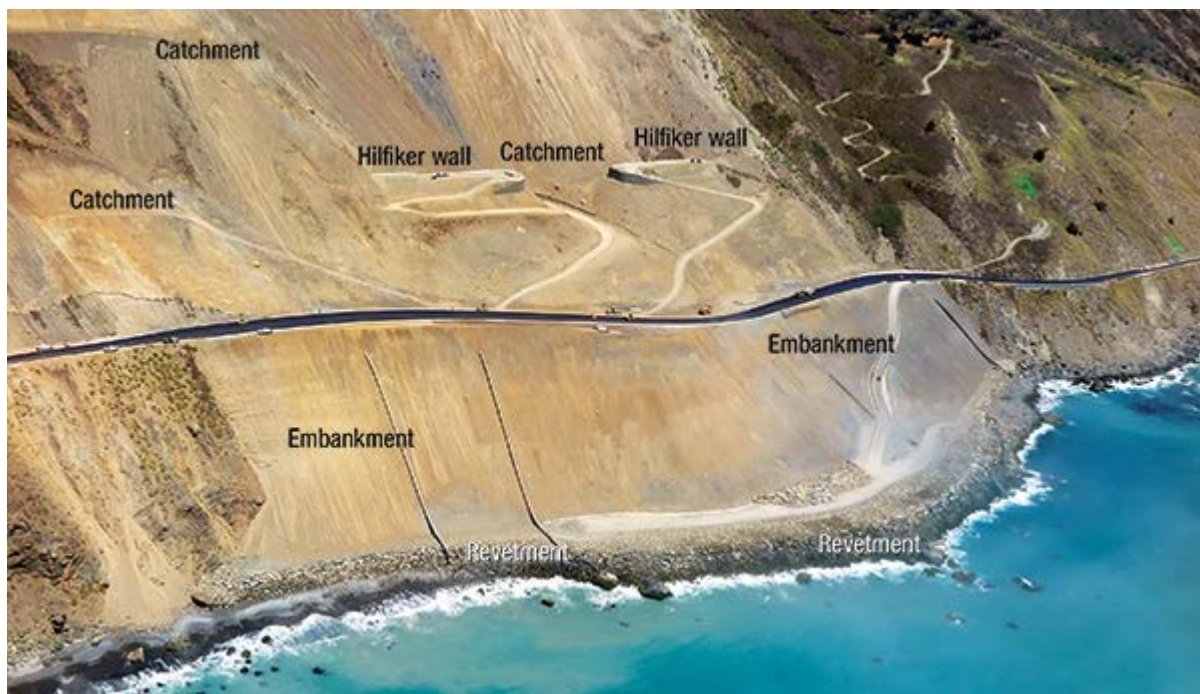
The main features of the completed project included a rock revetment at the toe of the landslide to control erosion, a new embankment built up from the revetment, and large earthen berms outfitted with a type of rock basket wall known as a Hilfiker wall to capture materials that travel downslope from the catchment above. COURTESY OF JOHN MADONNA CONSTRUCTION

Erosion caused by ocean wave action resulted in a steady retreat of the toe of the slide. To stanch this erosion, the contractor installed a rock revetment at the toe of the landslide. Extending for more than 2,000 ft along the new coastline, the revetment consisted of a trapezoidal structure made of rock that was keyed into the newly formed beach 6 ft below sea level and built to heights of 40 ft at the most exposed limits. Because of the large sizes of the required rocks, some of which weighed as much as 8 tons, the semi-trailer trucks used to haul the rocks could transport only two at a time. Overall, about 200,000 tons of rock would eventually be placed to build the revetment, which was designed by Caltrans staff. Coastal environment expert Gary Griggs, Ph.D., a distinguished professor of earth sciences at the University of California, Santa Cruz, provided input on this effort.

embankment built up from the revetment. To provide more outside width on the southbound side of the highway, the embankment was designed with an inclination ranging from 1.5:1 to 1:1. The extra width would be used in the future to stockpile slide material and store equipment. Additionally, the extra width could also be counted on to reduce the energy of future landslides by enabling large debris flows and runoff to flatten and spread, rather than remain in a more concentrated flow that would have more energy and thus more potential to incise into the new highway and embankment.

Concerns about potential damage to the highway caused by rockfall from the scarp prompted the project team to include protective elements as part of the design. A natural bowl or catchment had formed between the head of the main body and the bottom of the scarp. The project team improved this catchment by constructing large earthen berms on top of the head of the main body. A berm in its simplest form is a long, raised mound of soil. At Mud Creek, where everything is on a massive scale, these berms were more than 100 ft wide and 200 ft long measured at the top, towering 180 ft above the proposed realigned highway. Two rock-basket walls were added on top of the berms to further increase the capacity of the large bowls created by the landslide. Commonly known as a Hilfiker wall, these retaining walls were built with steel wire that is welded together to form mats. Rock is backfilled on top of each mat in lifts or horizontal sections. Another mat is placed and backfilled, and the process repeats until the wall is at the desired height.

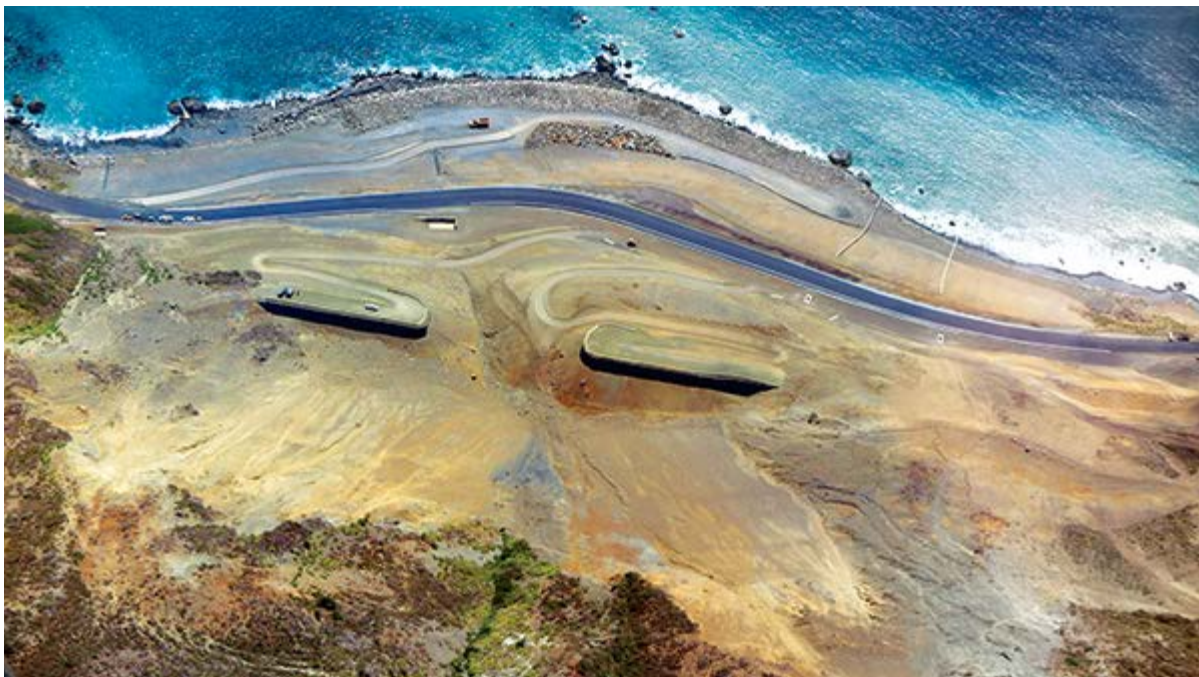
At the Mud Creek site, the rock basket walls were built up to about 25 ft in face height, dramatically improving the ability of the above-roadway catchments to protect the new highway below. COURTESY OF JOHN MADONNA CONSTRUCTION

At the Mud Creek site, these walls were built up to about 25 ft in face height, dramatically improving the ability of the above-roadway catchments to protect the new highway below. The walls stretch the entire length of the berms but with a gap between them to accommodate runoff and debris anticipated to flow down Mud Creek. To facilitate periodic maintenance of the catchments in the future, two maintenance access roads were graded with a series of switchbacks from the highway to the top of these walls. These roads, which are slightly more than 15 ft wide, enable such heavy equipment as long-reach excavators and dump trucks to ascend to the top of the wall. From there, excavators will be able to reach into the the natural bowl and transfer the material to the dump trucks.
